To keep our church beautiful and functional for years to come, many of our stained glass windows need significant repairs. The following pages detail the individual windows, the scope of work, and the estimated costs.

# OUR LADY of PERPETUAL HELP

Kansas City, MO

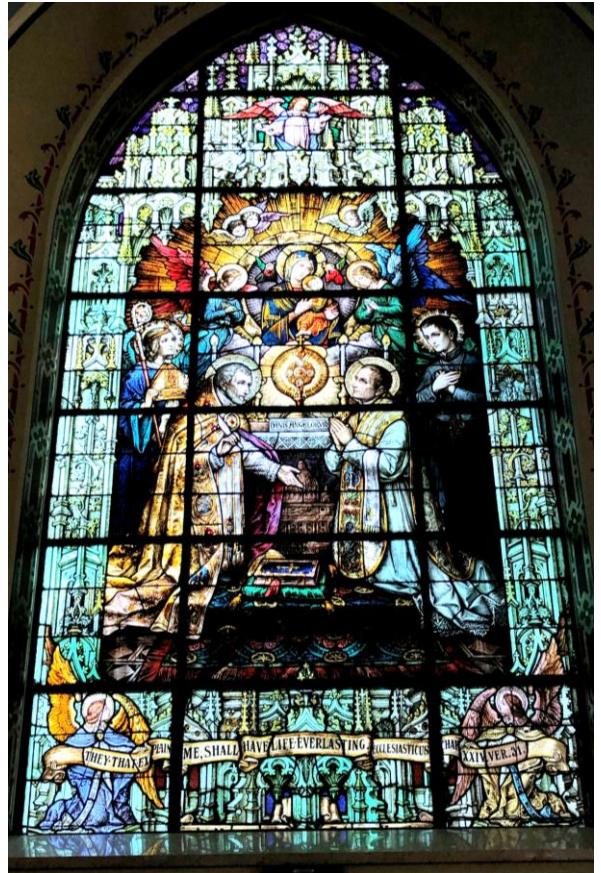
Window: A-1 Our Lady of Perpetual Help

Section 2-2 is badly bulged.

Section 2-5 has medium bulge.

Section 1-2 is bulging slightly, but the lead came is in terrible condition at the bottom left, with glass escaping the lead came.

Remove sections 2-2 & 2-5, flatten, solder broken joints, install new reinforcing bars. Remove section 1-2 to correct bottom corner damage.

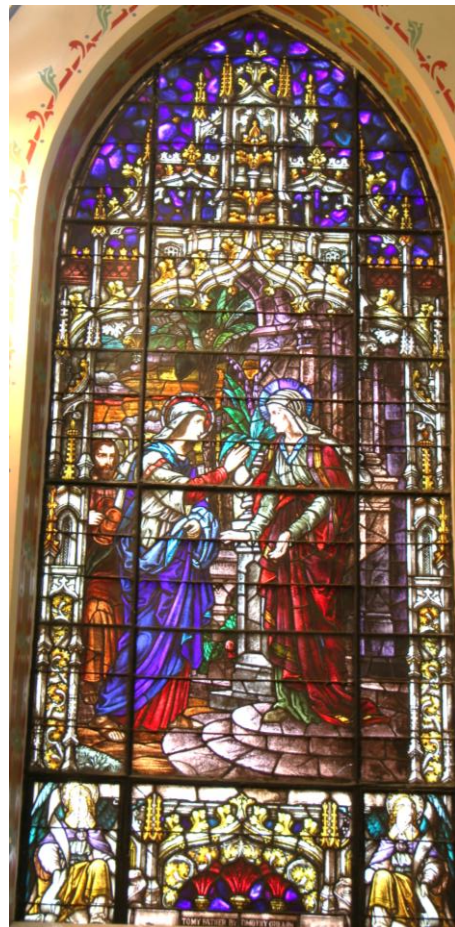
Window: C-2 Visitation

Section 1-2 has a slight bulge out.  
Section 2-2 has a crack in the bottom right stone piece. This could be lead-leafed to mask the crack. Steel frame is different—some sections are stacked and have a zinc divider separating them. Removal of any bottom sections of a stacked pair may require prior removal of the top section.

Lead leaf cracked piece in section 2-2. The slight bulge in section 1-2 is a low priority and could be deferred.

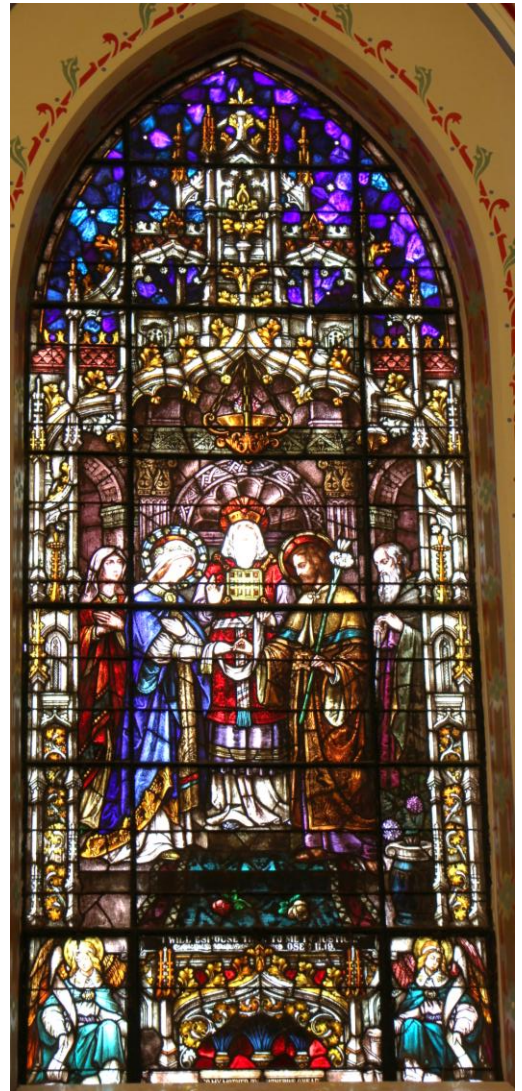
Window: C-3 Marriage of Mary & Joseph

Sections 2-1 & 2-2 have medium bulges.  
Sections 2-3 & 2-4 have slight bulges.  
Steel frame is different—some sections are stacked and have a zinc divider separating them. Removal of any bottom sections of a stacked pair may require prior removal of the top section.

Sections 2-1 & 2-2 could be removed, flattened, and rebarred. Medium priority.

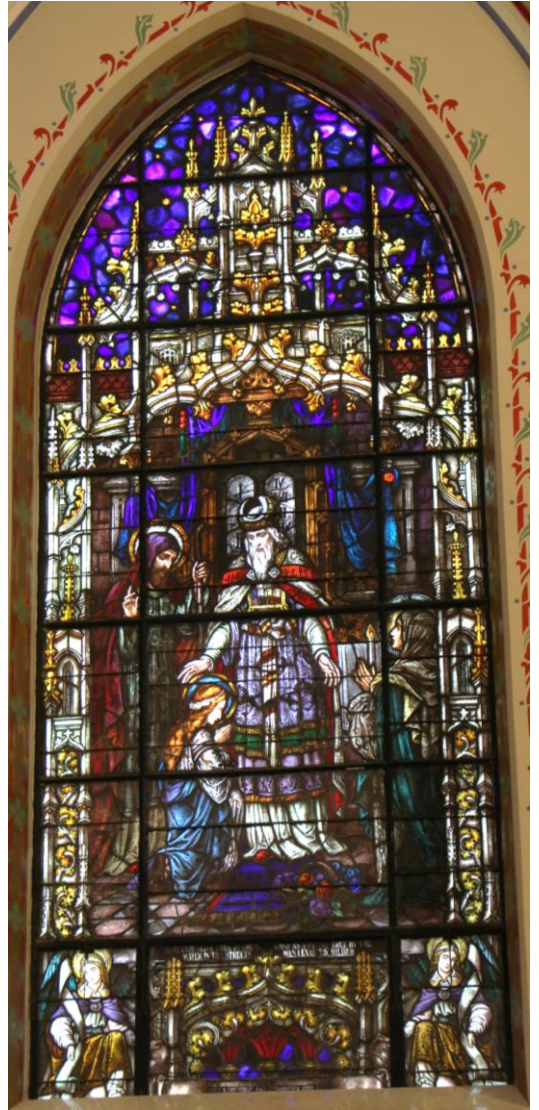
Window: C-4 Mary & Joseph in the Temple

Section 2-2 has a medium bulge out.  
Section 2-1 has 5 previous shattered pieces that have been lead leafed. If not objectionable, then leave as is.

Section 2-2 could be removed, flattened, and barred. Medium priority.

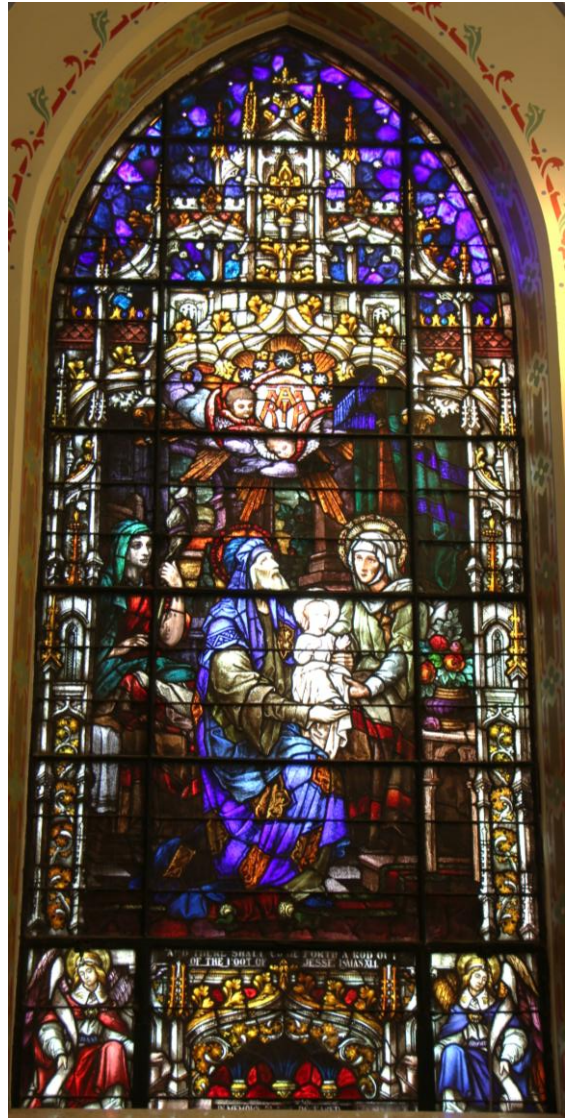
Window: C-5 Presentation in the Temple

Section 2-3 is badly bulged.

Sections 2-1 & 3-4 have medium bulges.

Remove section 2-3, flatten its bulge, rebar.

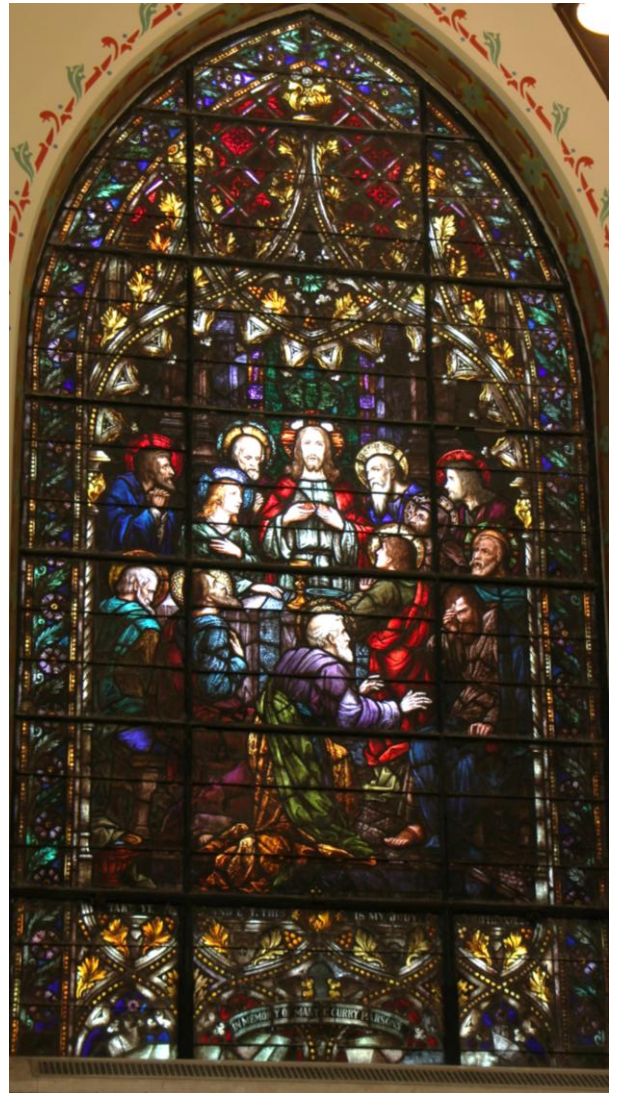
Window: A-6 Last Supper

Section 2-1 is badly bulged.

Sections 2-2, 2-3, & 3-3 have slight to medium bulges.

Bottom 3 sections have been reglazed in the past.

Stained glass is extremely dirty.

Remove section 2-1, flatten, rebar.

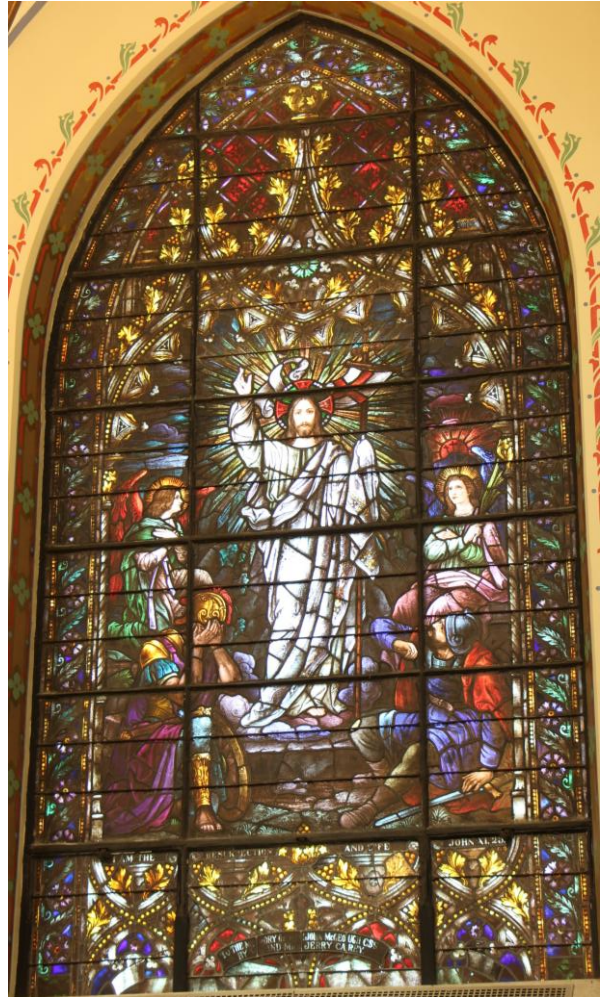
Window: A-7 Transfiguration

Major work done on this window in the past. The steel frame was replaced with an aluminum frame.

Bottom 3 panels were reglazed in the past.

No bulges.

Right vent will not shut tight. It appears to be jammed or blocked with debris and leaks air.

Right vent could be cleaned and sealed shut to prevent air leakage.

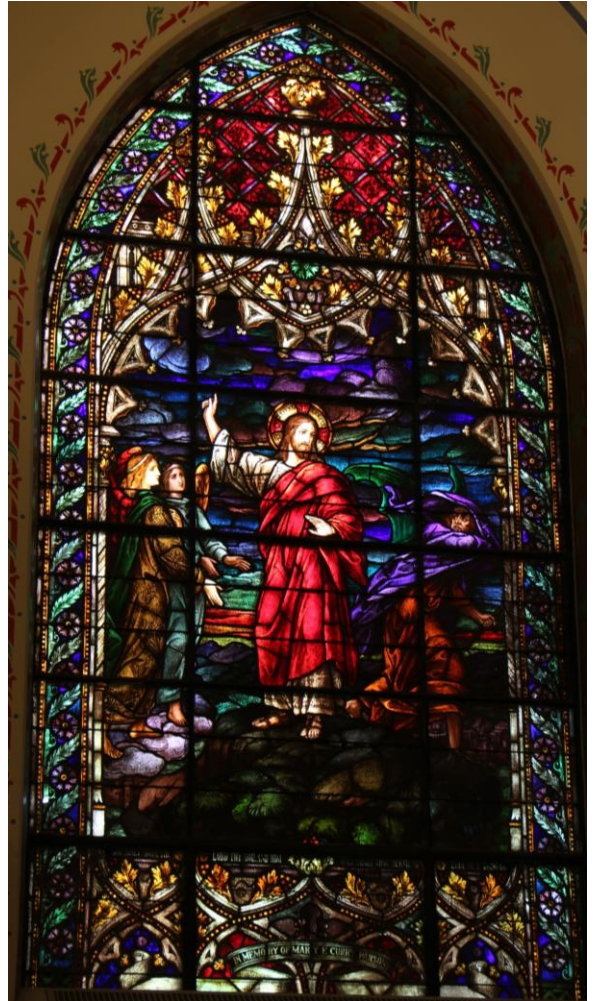
Window: A-8 Christ's Temptation in the Desert

Section 2-1 was reglazed and barred in the past, but is bulging again.

Sections 2-1, 2-2, & 2-4 have medium bulges.

Sections 1-2, 1-4, & 1-5 have slight bulges.

Section 1-2 has a hole at the bottom left in a green piece.

Section 2-1 has broken sticklites in the bottom horizontal that are not visible from the floor.

Repair hole in green piece in section 1-2. Remove, flatten, and rebar the medium bulges in sections 2-1, 2-2, & 2-4.

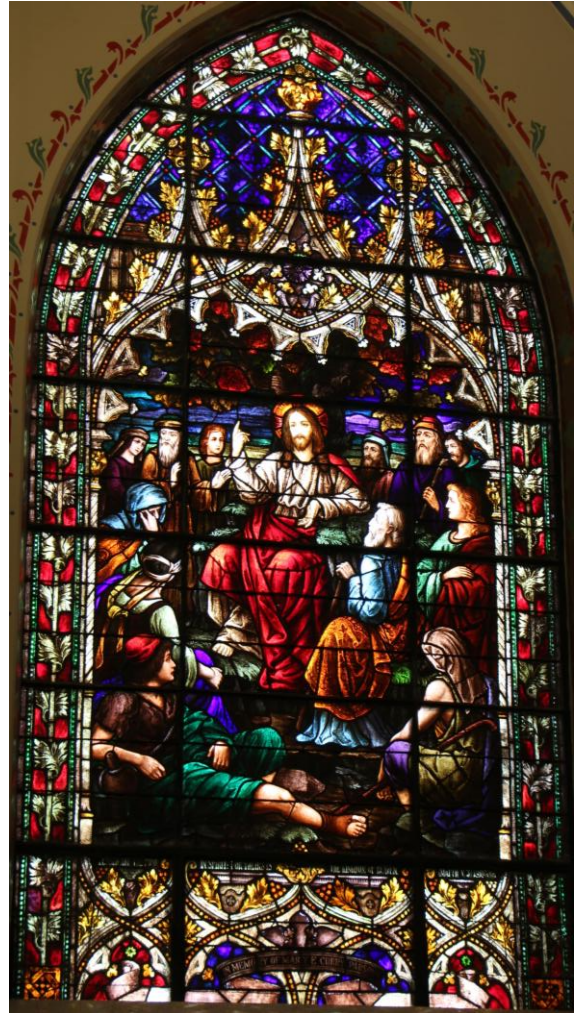
Window: A-9 Blessed are the poor in spirit

Sections 1-1, 1-2, & 1-3 were reglazed in the past.

Sections 1-1 & 2-5 have medium bulges. 1-1's bar is detached.

Sections 1-2 & 3-2 have slight bulges. 1-2's bar does not reach the perimeter of the window.

The glass is extremely dirty. . The window would benefit from a careful cleaning.

Remove sections 1-1 & 2-5 to flatten and rebar. Because 1-2's bar is not done correctly, consider doing the same.

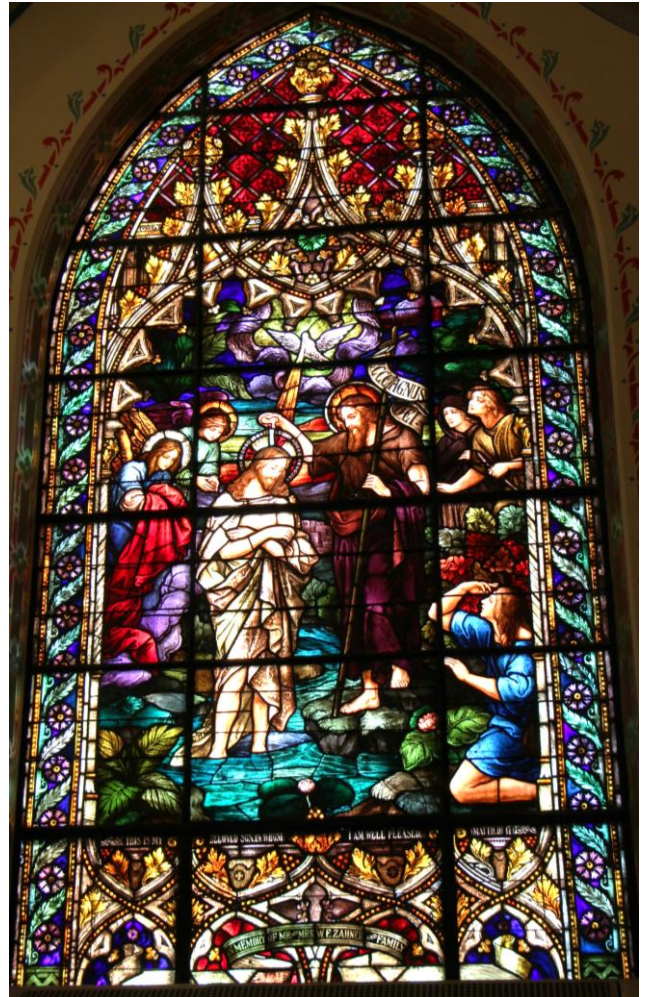
Window: A-10 Baptism of Christ

Sections 1-1, 1-2, 2-1, 2-2, & 3-1 have all been reglazed in the past.

Sections 2-1 & 2-2 have medium to bad bulges.

Sections 1-3, 2-4, 2-5, 2-6, 2-7, & 3-4 all have medium bulges.

8 bulged sections in total.

Sections 2-1 & 2-2 should be removed, flattened, and barred.

Consider as a medium priority fixing the bulges in the other 6 bulged sections.

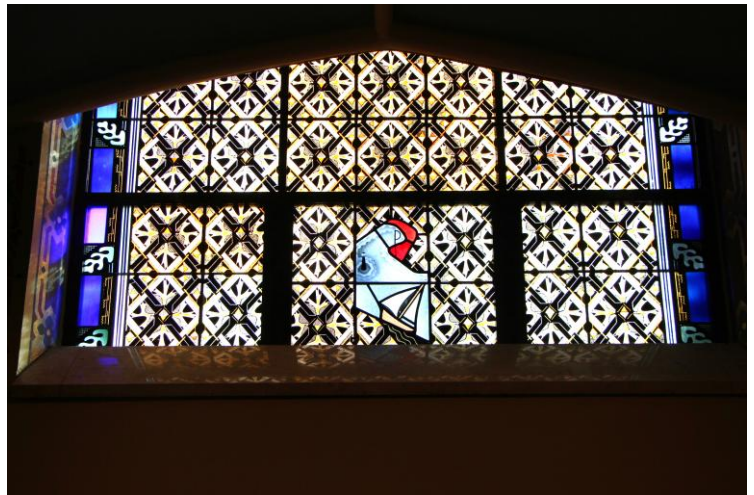
Window: A-11 St. Cecilia, design matches clerestory

The steel frame was replaced in the past with an aluminum frame. The frame bows substantially under light pressure. Steel reinforcement on the interior horizontal dividers is advised.

All panels are loose in the frames and were not caulked to prevent movement or rattling. Consider caulking some spots to make them more secure.

Left and right vents are switched and upside down. Though minor, these could be corrected by switching and turning 180 degrees.

To stiffen window frame, add at least 1 painted steel angle iron below the operable vent in the choir loft.

Caulk some spots around perimeter of each section of stained glass to keep them from moving or rattling.

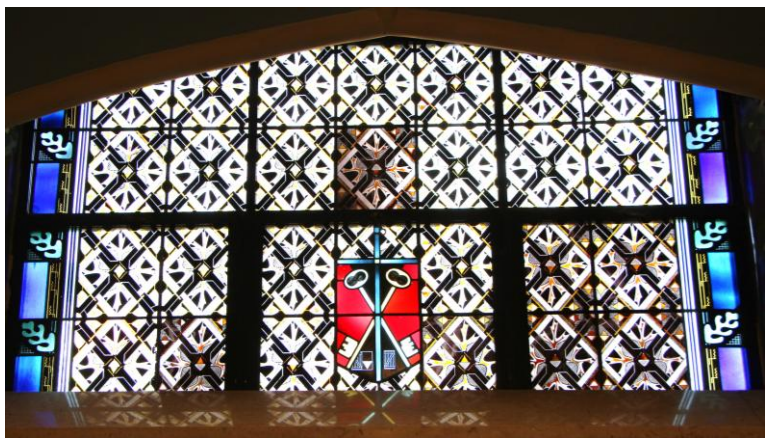
Window: A-12 St. Gregroy, design matches clerestory

The steel frame was replaced in the past with an aluminum frame. The frame bows substantially under light pressure. Steel reinforcement on the interior horizontal dividers is advised.

All panels are loose in the frames and were not caulked to prevent movement or rattling. Consider caulking some spots to make them more secure.

Many reinforcing bars no longer extend into the newer aluminum frame.

While no sections are bulged, this is not desirable. Because of the large rectangles of glass, no bulging has occurred.

To stiffen window frame, add at least 1 painted steel angle iron below the operable vent.

Caulk some spots around perimeter of each section of stained glass to keep them from moving or rattling.

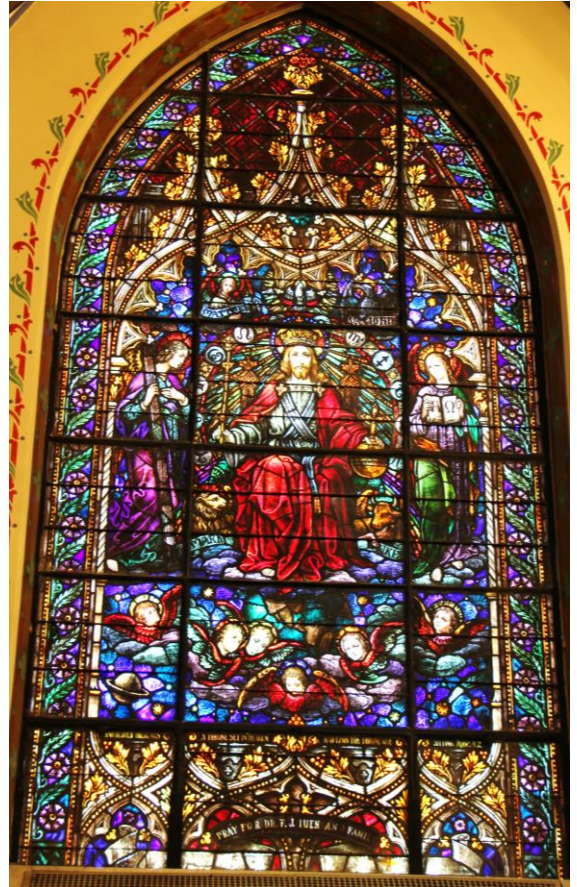
Window: A-13 Christ enthroned

Sections 1-1, 1-4, 2-2, 2-4, 2-5, & 3-1 were  
reglazed in the past.

Section 1-2 has a slight bulge.

Good condition.

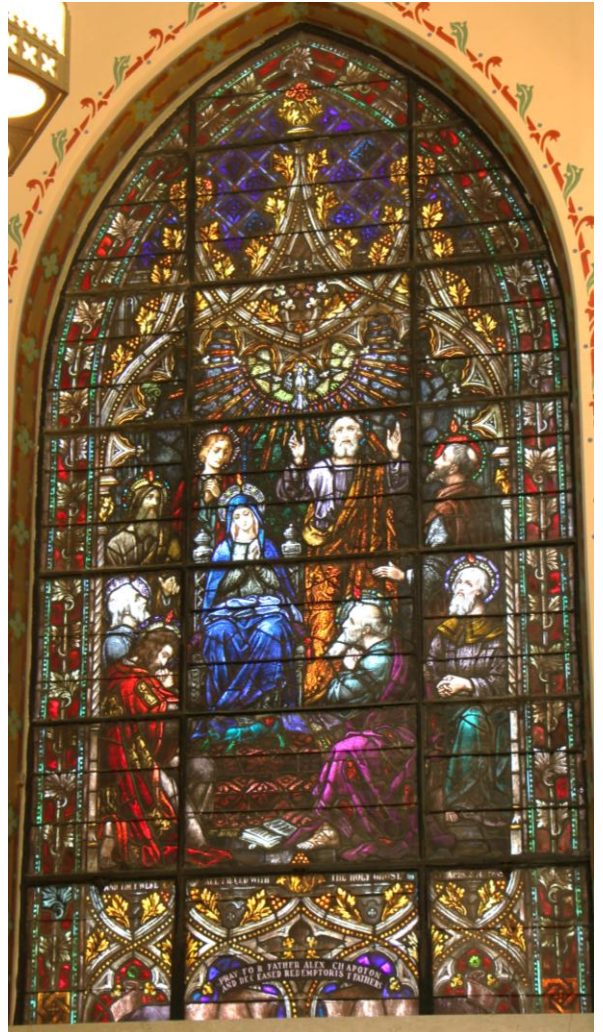
Window: A-14 Pentecost

Sections 1-1, 1-3, 2-1, 2-2, 2-5, & 3-1 were reglazed in the past.  
The top of section 2-6 is bulging in severely.  
Section 2-1 has a shattered ribbon piece at the bottom left.

Remove section 2-6, flatten, rebar. Replace shattered piece in section 2-1.

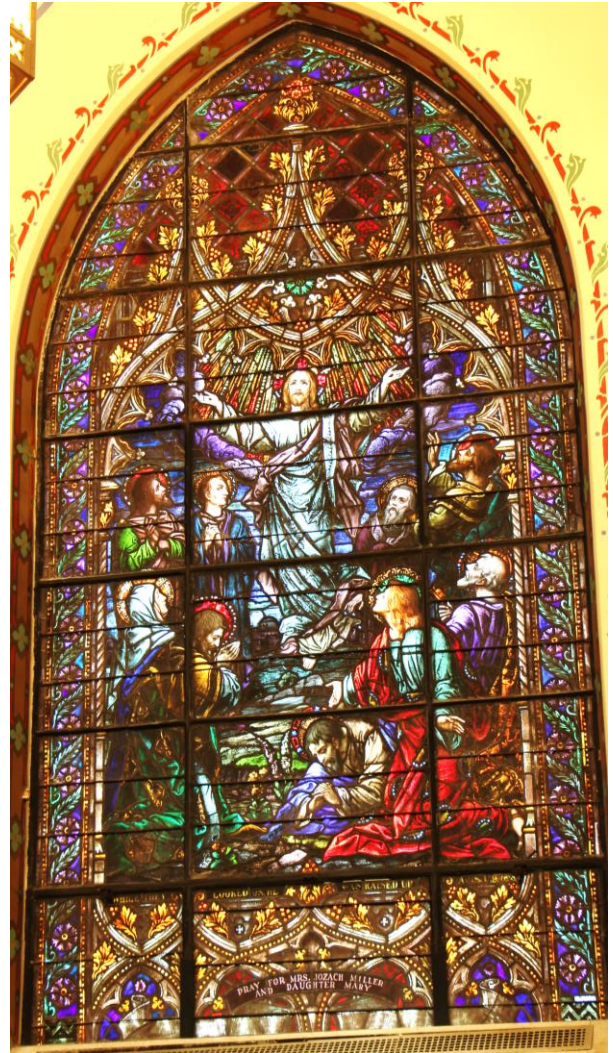
Window: A-15 Ascension

Sections 1-1, 1-4, 3-1, & 3-2 were reglazed.  
Sections 1-4, 1-5, 2-2, 2-6, & 3-1 have slight to medium bulges.

Section 1-6 is extremely bulged. It is a triangular section in the top curved area.

Remove section 1-6, flatten, rebar.

Consider if any of the 5 slight to medium bulges merit repair.

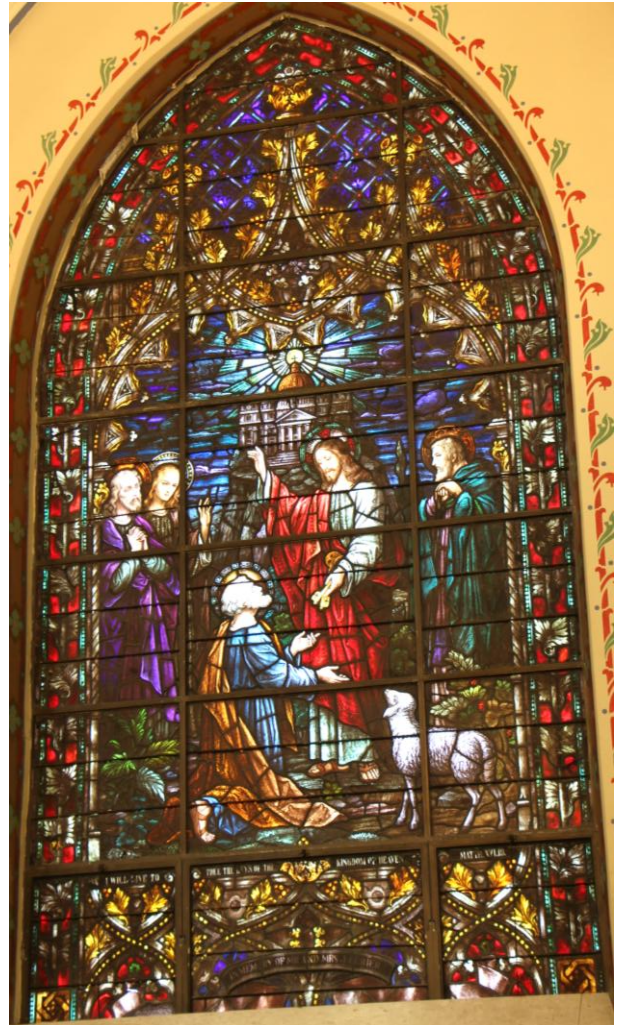
Window: A-16 Peter & the Keys

Section 1-1 has a shattered scroll piece under the reinforcing bar.

Sections 1-4, 1-5, 1-6, 2-1, 3-6 were reglazed.

Section 3-2 has 3 shattered pieces, but not visible from the floor.

Section 3-1 has 2 shattered pieces.

Section 2-1 has 3 shattered pieces. Someone previously applied caulk over most of the above cracks to hide them.

If desired, we can replace any of the 9 shattered pieces.

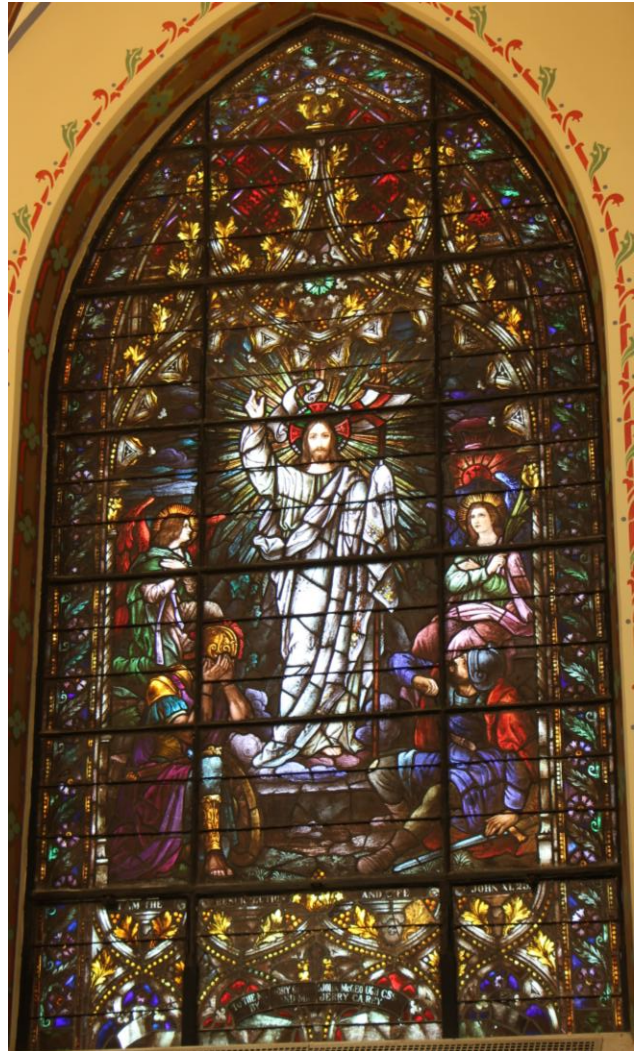
Window: A-17 Resurrection

Sections 1-1, 2-1, 2-5, 2-7, & 3-1 were reglazed in the past.

Sections 2-5 & 2-7 have medium bulges.

Section 1-2 has a purple cloak piece that is cracked. Suggest lead leafing.

Consider repairing medium bulges in sections 2-5 & 2-7. Apply lead leaf or replace cracked piece in section 1-2.

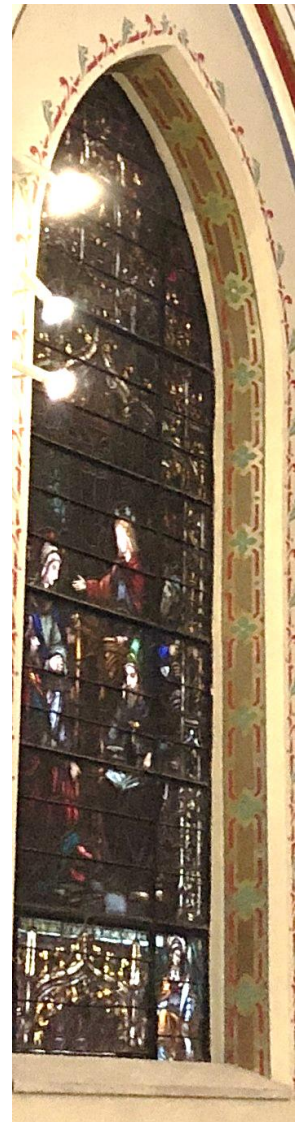
Window: C-18 Finding of Christ in the Temple (missing photo)

Good condition. No bulges.

Section 3-2 has a shattered leaf/vine piece behind a bar. May need to be repaired from the exterior and have the exterior glass removed to do so.

Consider repairing shattered piece in section 3-2 from the exterior.

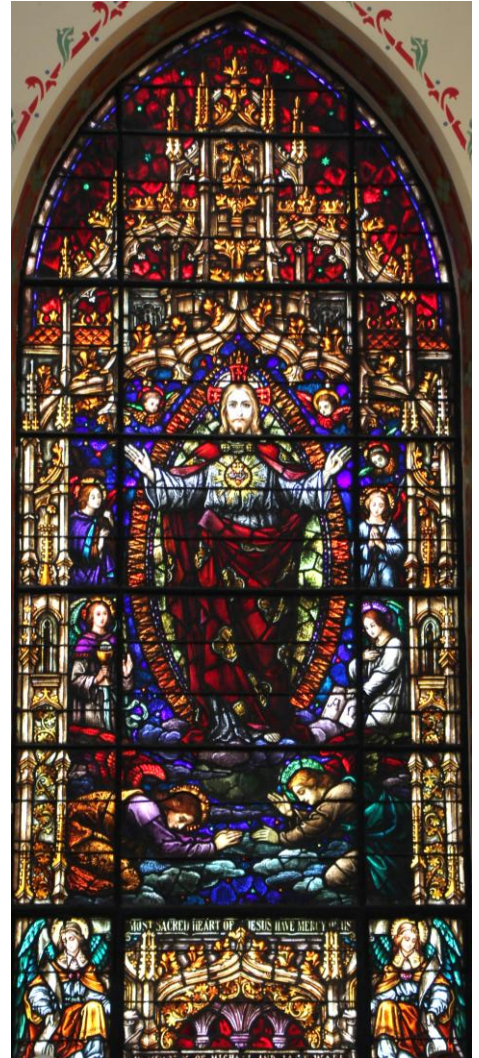
Window: C-19 Sacred Heart

Section 2-2 bulged out at the top.  
Good condition otherwise.

Consider repairing bulged section 2-2.

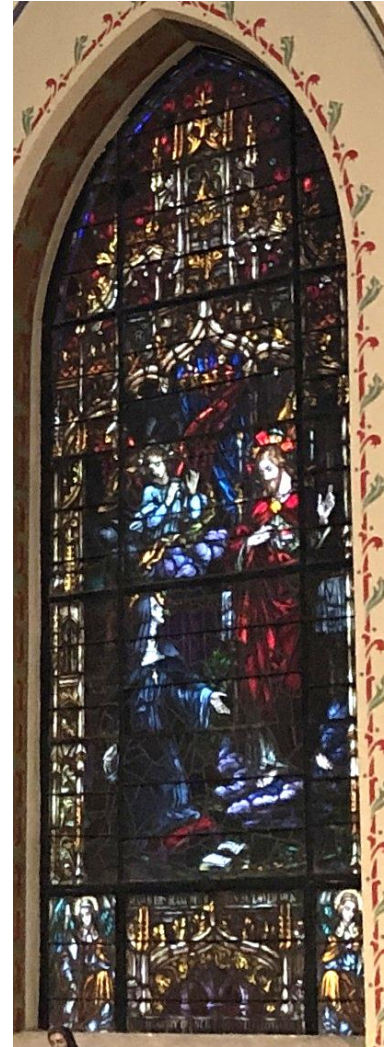
Window: C-20 St. Margaret Mary Alacoque

Section 2-4 was reglazed in the past.

Section 1-4 & 2-7 have slight bulges.

Section 1-2 has a crack in the bottom right corner. This can be lead leafed.

The steel frames are different in this window. The horizontal dividers between sections 2 and 3, between sections 4 and 5, and between sections 6 and 7 are zinc dividers and not steel. Sections are stacked in pairs rather than independently supported. Any repairs to the bottom section of a stacked pair may require the top section to be removed as well.

Very little needed. Consider repairing slight bulges or fixing the cracked piece in section 1-2.

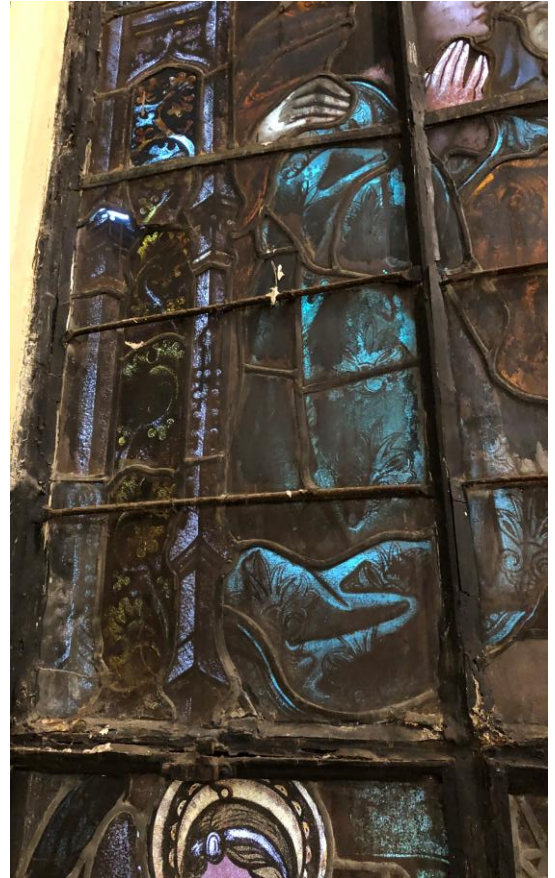
Window: C-21 Let the children come to me  
(missing large photo)

Badly damaged and restored in past, still damaged.

Sections 1-1, 1-3, 2-2, 2-3, 2-4, 2-5, 2-6, 2-7, 3-2, 3-3, 3-4, & 3-5 reglazed and rebarred, but the bars are severely rusted.

Sections 1-2, 1-3, & 2-2 are badly bulged. 3-3 is slightly bulged.

Section 1-3 is missing a bar and 1-4 has no bars.

Section 3-4 has a hole/crack at bottom right.

Angels in two vents are bad past repairs.

Steel frame is different—some sections are stacked and have a zinc divider separating them. Removal of any bottom sections of a stacked pair may require prior removal of the top section.

Completely restore sections 1-2, 1-3, & 2-2. Replace broken/bad past repairs in those sections. Fix cracks in other sections.

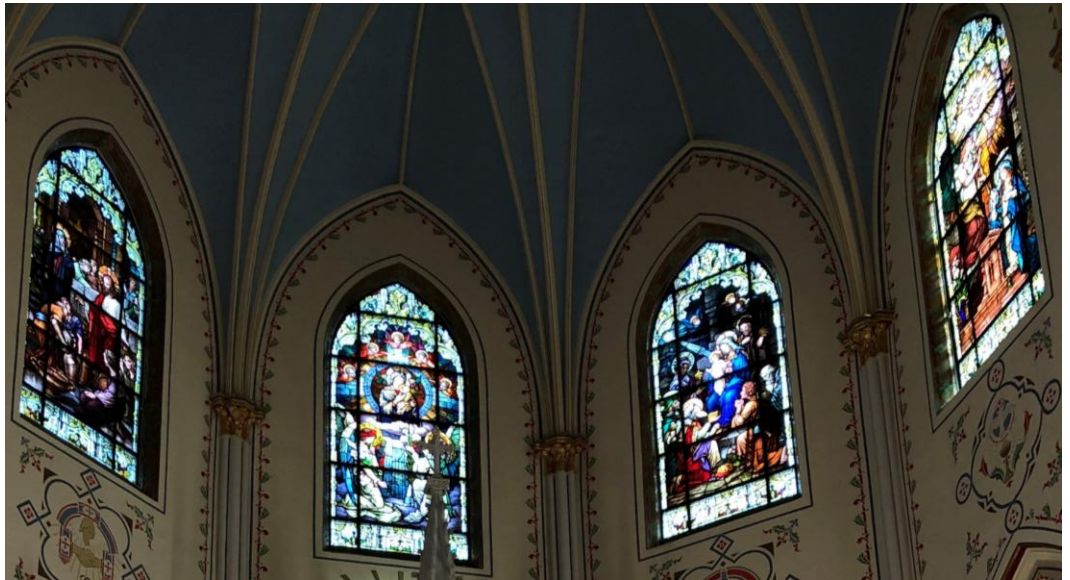
Window: B-23, 24, 25, 26, 52, 53, 54

Viewed up close from the exterior roof. These 7 windows received new protective coverings circa 2001. The stained glass appeared to be in excellent condition.

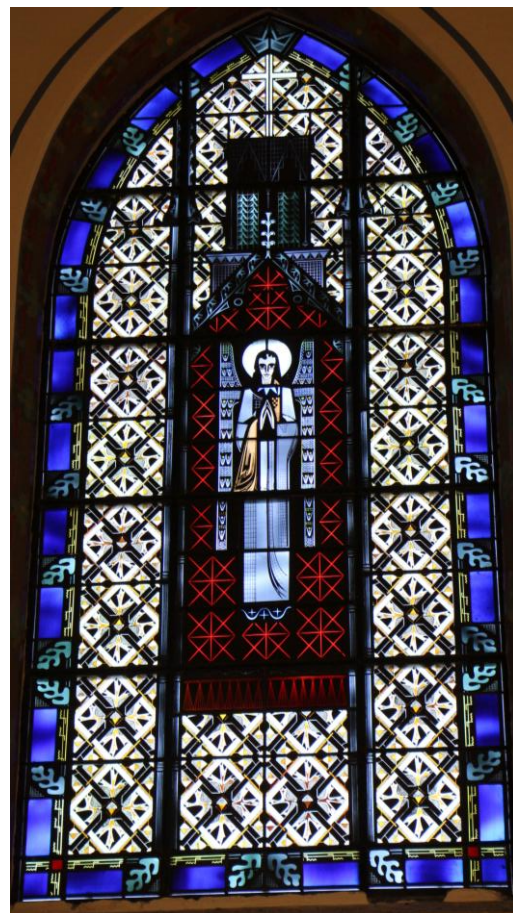
Viewed majority of windows from the roof exterior (none on North nave roof). Because of the large pieces of glass, there was no bulges found.

The only minor damage found was cracked lead came, which is normal and causes no current structural weakness to the window, as the perimeters are trapped and cannot expand to open the cracked leads.

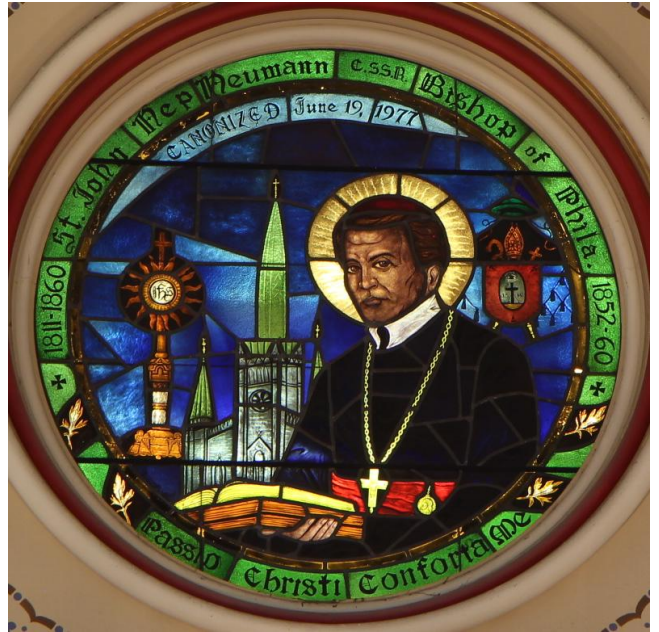
Window: D-39 St. Neumann circle

This window is an interior window installed from inside the organ loft/tower. It is in excellent condition with no damage.
